LAKE PENNESSEEWASSEE WATERSHED SURVEY REPORT

JANUARY 2020

Lakes Association of Norway

Lake Penneesseewassee Watershed Survey

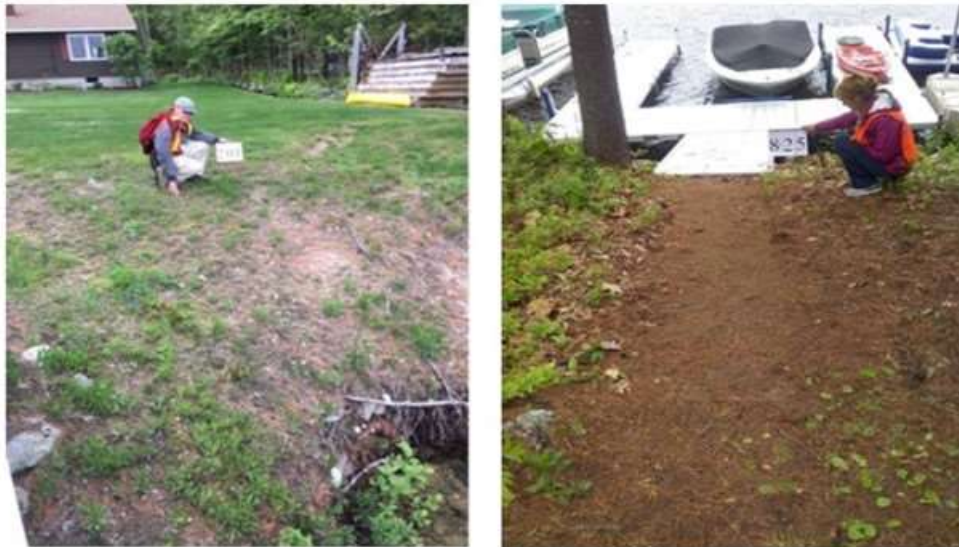
Figure 7. Heavy foot traffic, lack of vegetation and raking of pine needles make residential shoreline areas very susceptible to erosion

- Install runoff diverters/rubber razors.
- Define and stabilize footpath.
- Build infiltration steps.
- Avoid raking pine needles. Add mulch / erosion control mix to paths and trails.
- Reseed any bare soil and thinning grass, especially along shoreline.
- Establish buffer and add to buffer along shoreline.
- Build infiltration trench at roof dripline.

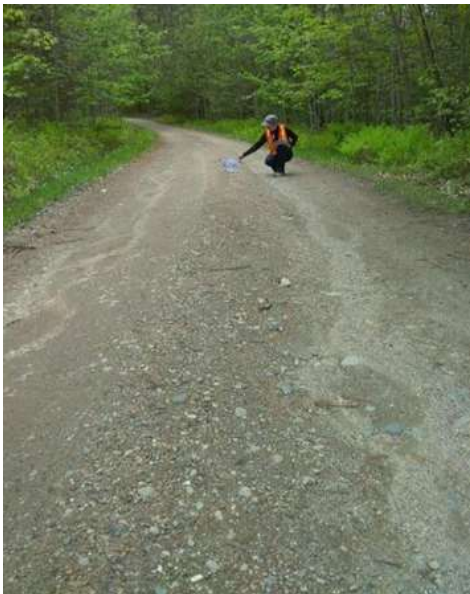
Figure 8. Erosion on the surface of this private road washed into a ditch then into a stream that feeds Lake Pennesseewassee

- Replace failing or undersized culverts. Armor both ends of culvert with stone.
- Remove plow and grader berms that prevent runoff from getting off roads.
- Install runoff diverters (open top culvert, rubber razor or water bar).
- Stabilize road shoulders with gravel or stone.
- Stabilize road surface with hard-packing gravel and grade/crown to shed water.
- Reshape ditches and armor with stone.
- Employ Maine DEP certified contractors for road work.
- Utilize Maine DEP’s guidance documents for forming a road association and conducting road maintenance.

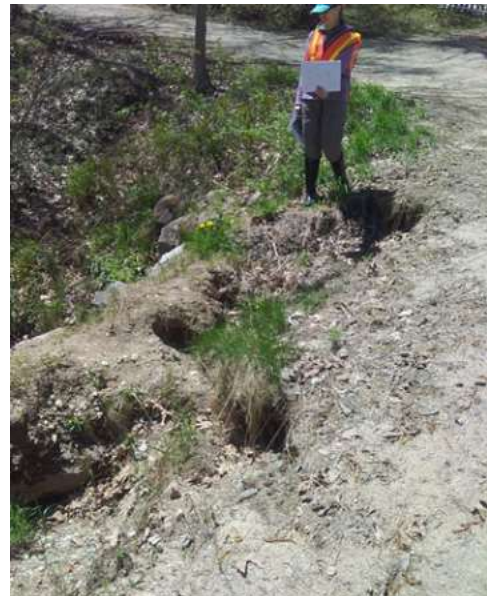
Figure 9. Severe erosion at a culvert

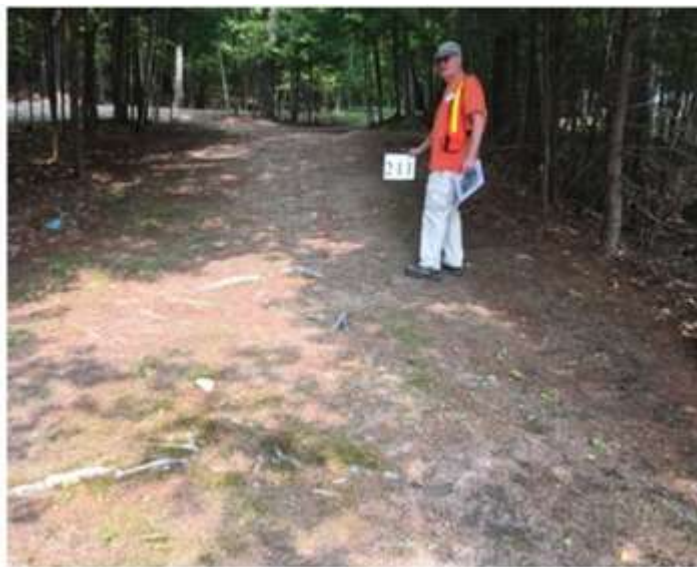
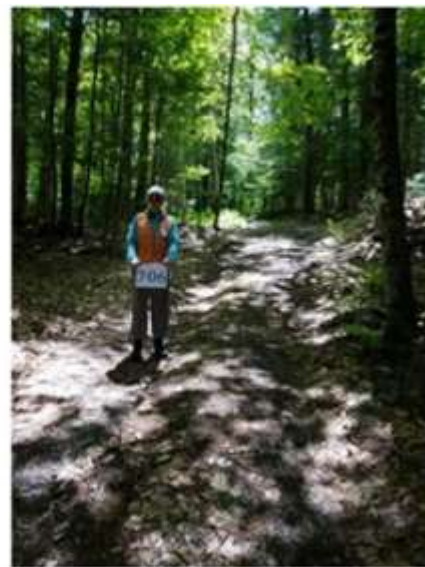
Figure 10. Runoff concentrates on these driveways then the eroded material washes into the lake

- Add new surface material, such as gravel.
- Reshape and crown driveway surface.
- Install runoff diverters (open top culvert, rubber razor or water bar).
- Define parking area and vegetate temporary driveways.
- Build a rain garden and establish vegetated buffer.
- Install gutters and drywell for roof runoff.
- Armor inlet/ outlet of culvert and install a plunge pool.
- Reshape ditches and armor with stone.

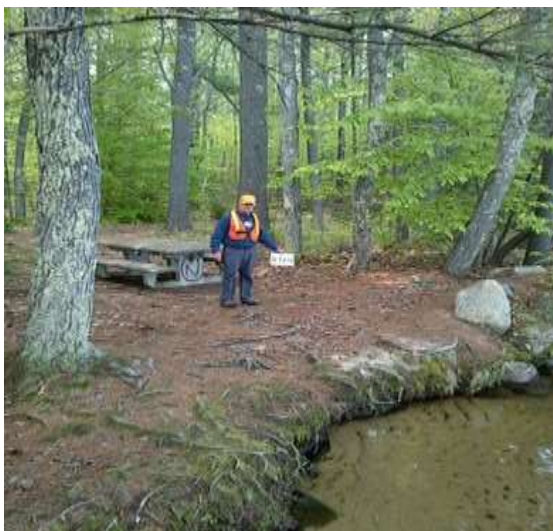
Figure 11. Lack of a vegetation buffer has resulted in shoreline erosion in this picnic area

- Don't utilize unprotected areas close to waterbodies, near ditches that can carry pollution into a waterbody.
- Armor heavily used areas to prevent erosion.
- Use silt fence or berm to contain erosion on construction sites.
- Apply Erosion Control Mulch.
- Establish shoreline buffers.

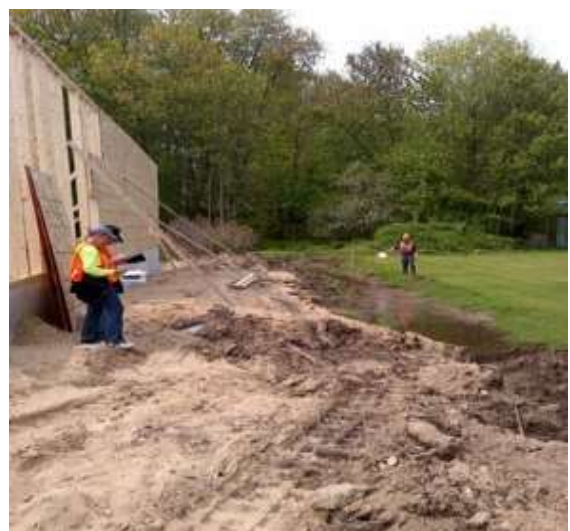
Figure 12. A construction project with inadequate protection of a ditch that leads to the lake
