NORTH POND WATERSHED SURVEY REPORT

APRIL 2017

The Lakes Association of Norway

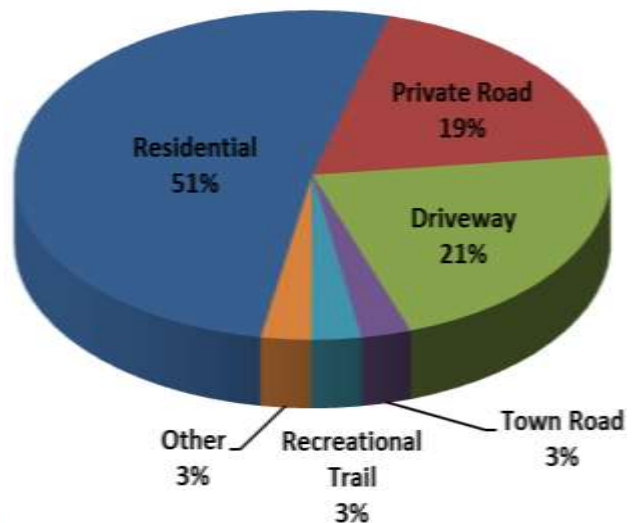
Figure 2 Land Use, Impact and Costs of Erosion Sites

The watershed survey documented 37 problem sites (Figure 2). Land uses associated with the erosion sites included residential, private road, driveways and other. In terms of water quality impact, 19 sites were rated low, 16 sites were rated medium and 2 sites were rated high. For the estimated cost to fix, 24 sites were rated low ($\$ < 500$), 10 sites were medium ($\$ 500 - \$ 2,500$) and 3 were high cost ($> \$ 2,500$). The land uses with the greatest numbers of problems are highlighted on the following pages in greater detail.

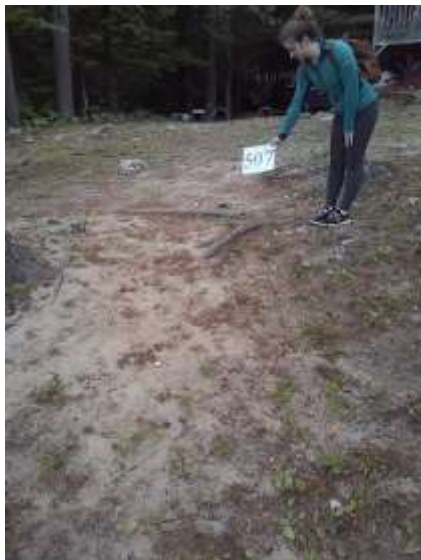
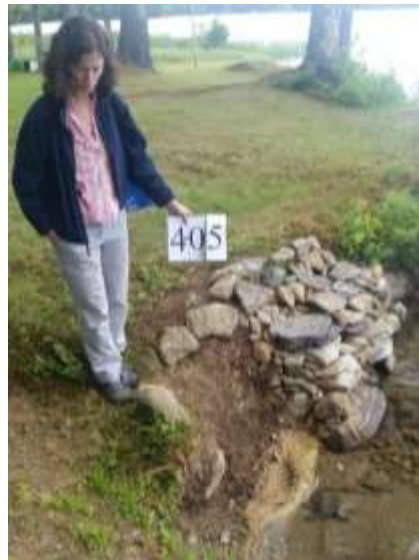
Residential areas accounted for more than half (51%) of identified erosion sites in the watershed. 15 out of 19 of the residential sites were determined to be low impact and the remaining 4 sites were ranked medium impact. All of the residential sites were determined to be low cost. The most frequent problem on residential properties in the watershed is sheet erosion, often with bare soil, flowing directly into the lake. Rill erosion (i.e., with observable small channels carved into the soil) was another common problem along with inadequate shoreline vegetation, and unstable shoreline access. Depicted below are some examples of the most common problems on residential sites and general recommendations that landowners can follow to prevent erosion and improve the water quality in North Pond.

Heavy foot traffic and lack of vegetation along the shoreline make residential shoreline areas very susceptible to erosion.

- Install runoff diverters/ rubber razors.
- Define and stabilize footpath. Build infiltration steps.
- No raking pine needles. Add mulch / erosion control mix to paths and trails.
- Reseed any bare soil and thinning grass, especially along shoreline.
- Establish buffer and add to buffer along shoreline.
- Build infiltration trench at roof dripline.

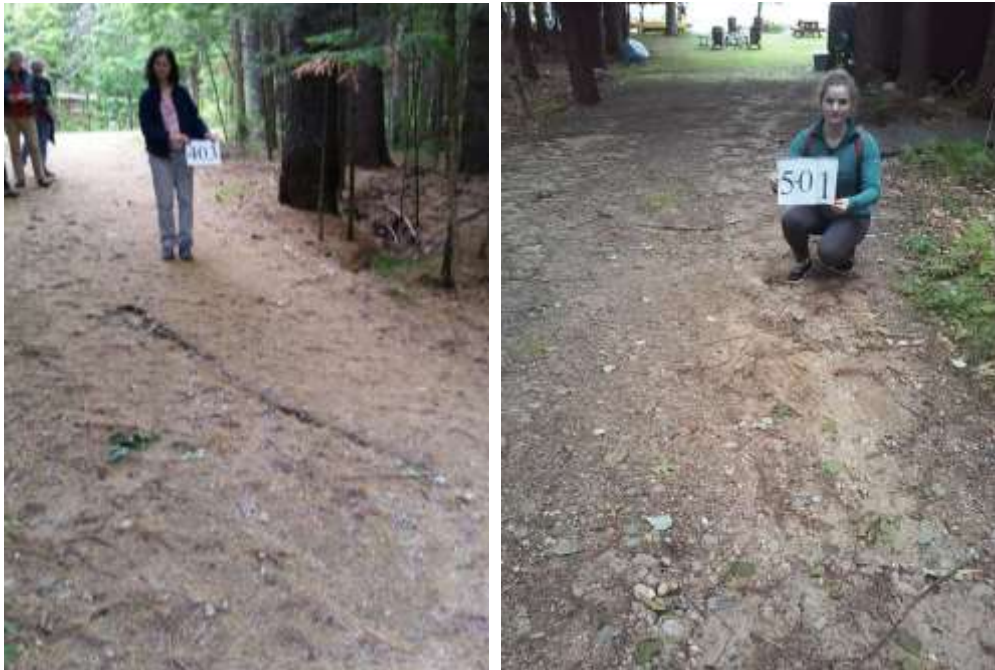
Driveway sites accounted for 21% of identified sources of polluted surveyed in the North Pond watershed. Eight driveway sites were documented during the survey, two of which were determined to be low impact and the remaining six sites were ranked medium impact. Six driveway sites were determined to be in the medium cost category (\$500-\$2500), and two driveway sites fit into the low cost category (under \$500). There were no high cost category driveway sites. The most common driveway problems and recommended solutions are shown and described below.

Runoff concentrates on these driveways, and the eroded material washes to the pond.

- Add new surface material, such as gravel.
- Reshape and crown driveway surface.
- Install runoff diverters (open top culvert, rubber razor or waterbar).
- Define parking area and vegetate temporary driveways.
- Build a rain garden and establish vegetated buffer.
- Install gutters and drywell for roof runoff.
- Armor inlet/ outlet of culvert and install a plunge pool.
- Reshape ditches and armor with stone.

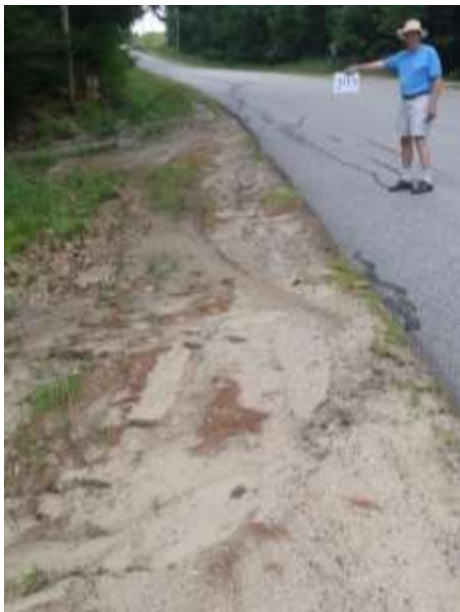
The shoulder along this steep town road erodes into a stream that flows into North Pond.

- Replace failing or undersized culverts. Armor both ends of culvert with stone.
- Remove plow and grader berms that prevent runoff from getting off roads.
- Stabilize road shoulders with gravel or stone.
- Stabilize road surface with hard-packing gravel and grade/crown to shed water.
- Reshape ditches and armor with stone.
- Employ Maine DEP certified contractors for road work.
- Utilize Maine DEP's guidance documents for forming road association and road maintenance.

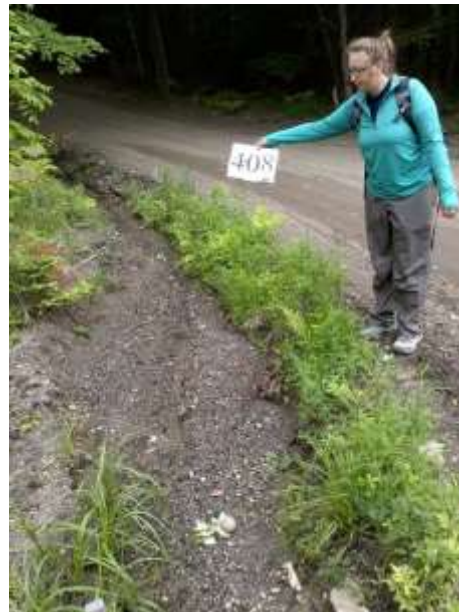
Erosion in the ditch and road surface of this private road washes into a stream and then North Pond.
