North Pond Watershed Protection Project—Phase I 2017-2019

Project Summary of Accomplishments

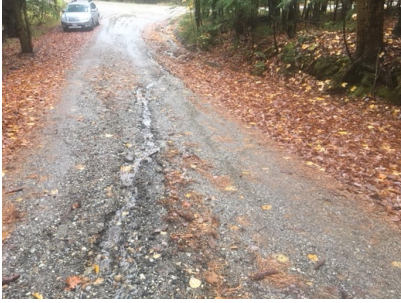
Before (top): Beaver Way's road surface was experiencing significant erosion due to poor surface material and insufficient crowning. Ditches were extremely unstable and eroding as well due to high runoff volumes.

Problems on Beaver Way were contributing the largest amount of sediment (16.77 tons/year) of any site in the watershed. This was the first priority for the project to tackle. The road was completely re-surfaced with less erodible gravel material and re-shaped to shed runoff as sheet flow towards ditches. A rubber razor diverter was also installed to help direct flow to the ditches. The ditches were also re-shaped and armored with rip-rap (large angular rock). Cross culverts were installed with armored inlets and outlets and sediment pools with level spreaders at the outlets of the culverts to slow and disperse stormwater.

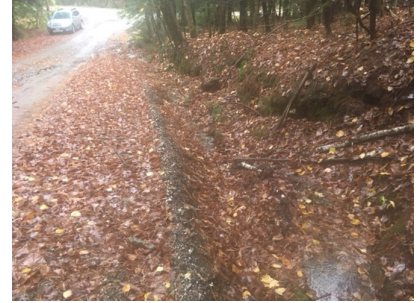
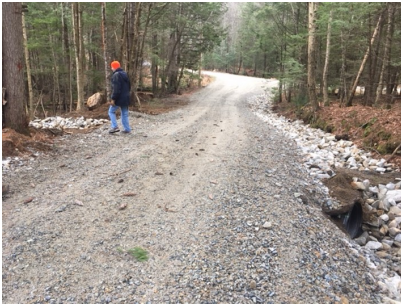
After (bottom): With new cross-culverts, turnouts and stabilized ditches, sediment is no longer carried to the stream tributary or the pond.

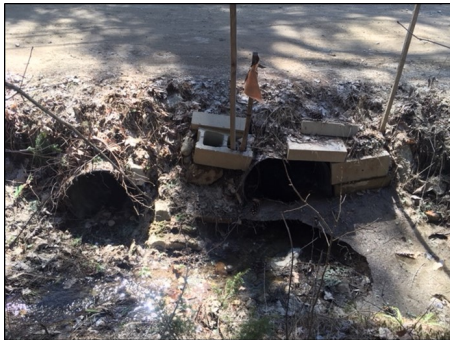
Before (Left): Sediment choked culvert inlets.

Three sites on Jackson way received cost-share funding to address unstable cross culverts and road ditching. Ditch Turnouts were also created in several areas to decrease flow volume heading downhill which can overwhelm culvert capacity.

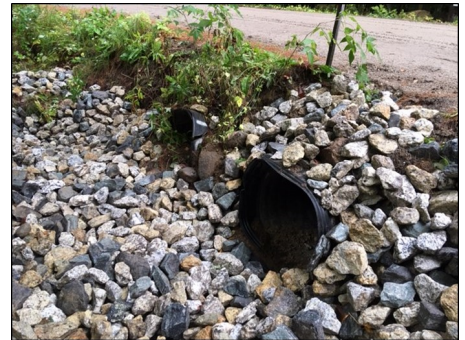
After (Right): Reshaped and rip-rap stabilized ditches and culvert inlet.

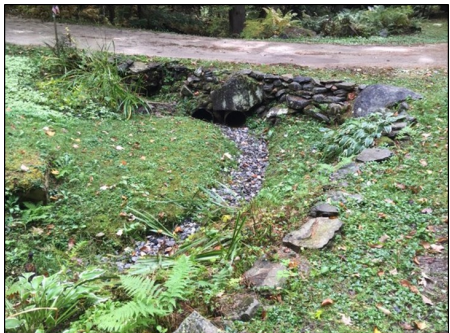
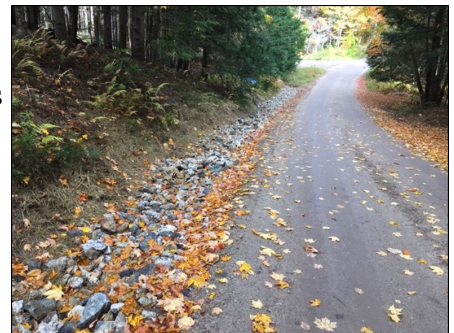
After photos of a stabilized by-pass channel (left) and stable ditches (right).

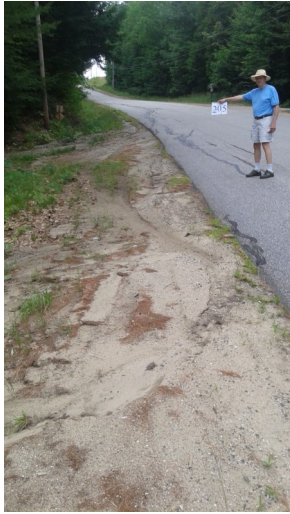
Before: Eroding road shoulders.

The Town of Norway stepped up to do some improvements on a section of Crockett Ridge Rd that had eroding shoulders and ditches that were sending large amounts of sediment into a stream tributary. They applied “Reclaim”, a mixture of gravel and crushed asphalt, to the shoulders to stabilize them. A level spreader sediment pool was created before the stream.

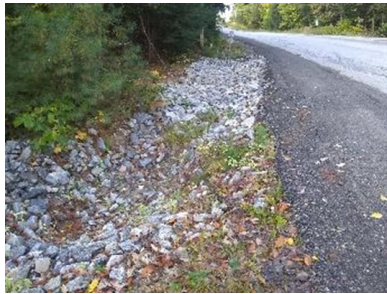
After (above): Rip-rap stabilized ATV trail entrance, “Reclaim” on the shoulder, plunge pool with level lip spreader at the terminus of the ditch before the stream crossing.

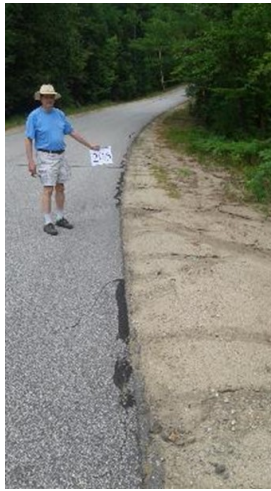
Before: Eroding gravel shoulder at stream crossing culvert.

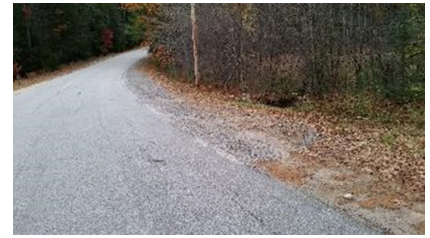
After (above): Shoulder stabilized with 3/4” crushed gravel.

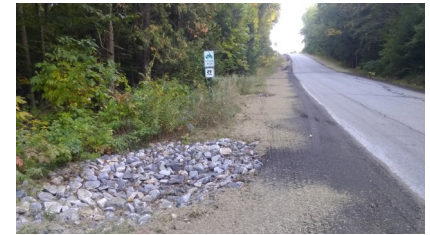
After (above): Shoulder stabilized with Reclaim and rip-rap.

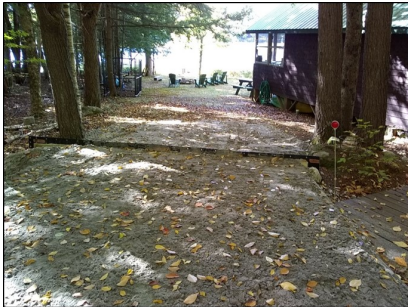
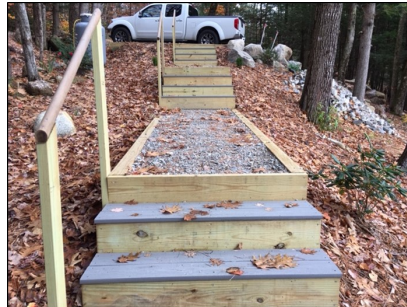
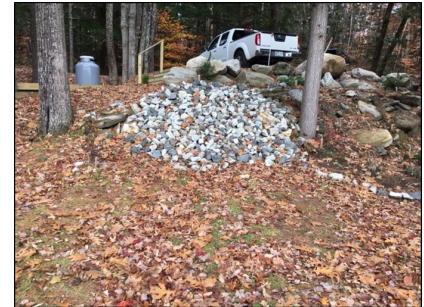
Most of the erosion problems from stormwater runoff identified during the 2015 Watershed Survey were on residential properties and driveways. Several properties were addressed with driveway improvements that diverted runoff into stable vegetation, such as installing rubber razors (below left). One property on Jackson lane upgraded the steep stairs that led to the camp with new infiltration steps (center) which allow runoff to absorb into the ground through the gravel. Stabilizing a steep slope with rip-rap (right) is another BMP that was used to reduce erosion.

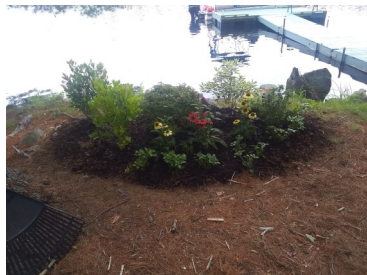
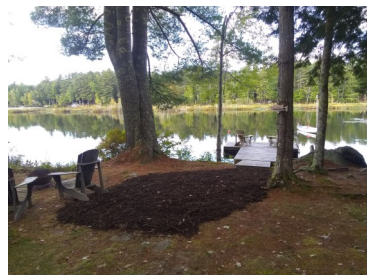
Shoreline buffers, planted on over a half dozen properties, help to absorb runoff and filter phosphorous before it reaches the pond where it could feed algae growth. Pathways protected with Erosion Control Mix mulch, and stone applied under roof driplines were other effective methods used to reduce erosion. These landowners received Residential Matching Grants to help defray expenses.
