**Lake Pennesseewassee Watershed-Based
Protection Plan
2020-2029**

February 2020

Lakes Association of Norway (LAON)

LAKE PENNESSEEWASSEE WATERSHED SURVEY REPORT

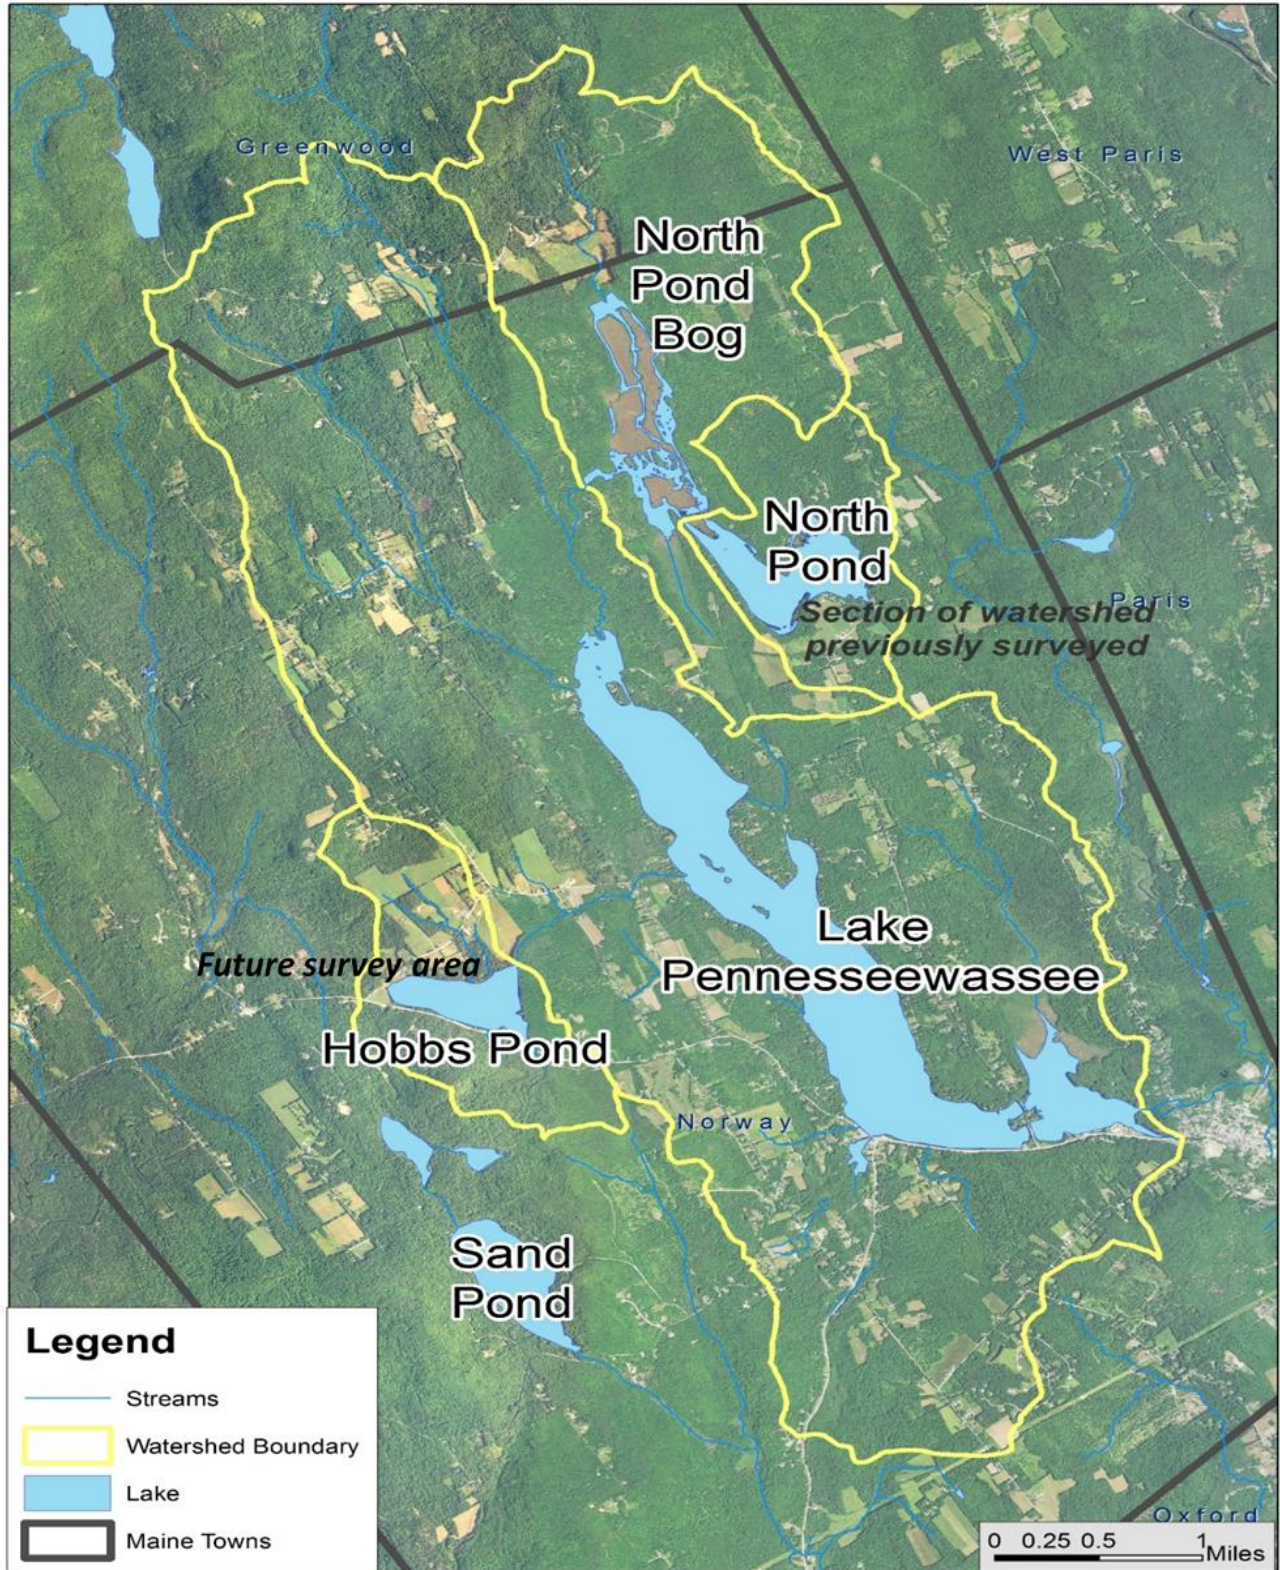
Figure 1 – Map of Lake Pennesseewassee Watershed

Additional phosphorus flowing into Lake Pennesseewassee from North Pond and Hobbs Pond contributes to the phosphorus loading in Lake Pennesseewassee, which has the potential to lead to more algae growth. The lake's outlet stream flows from the southeast corner of the lake into a tributary of the Little Androscoggin River (Figure 1). Lake Pennesseewassee is a key resource to Norway and its surrounding areas because of the important recreational resources and economic benefit it provides. LAON's long range plan is to conduct surveys and develop protection plans for all our watersheds, as resources allow. Surveys have already been completed for Lake Pennesseewassee (including the North Pond Bog) and North Pond. Surveys still need to be completed for Hobbs Pond and Sand Pond.

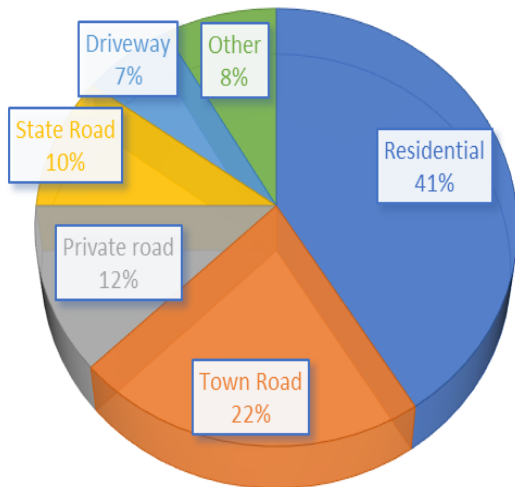
Figure 3. Land Use of Sites

Land Use	High Impact	Medium Impact	Low Impact	Total # of Sites	% of Total
Residential	1	17	56	74	41
Town Road	3	26	10	39	22
Private road	0	16	6	22	12
State Road	2	10	6	18	10
Driveway	1	6	5	12	7
Other	2	6	7	15	8
TOTAL	9	81	90	180	100%

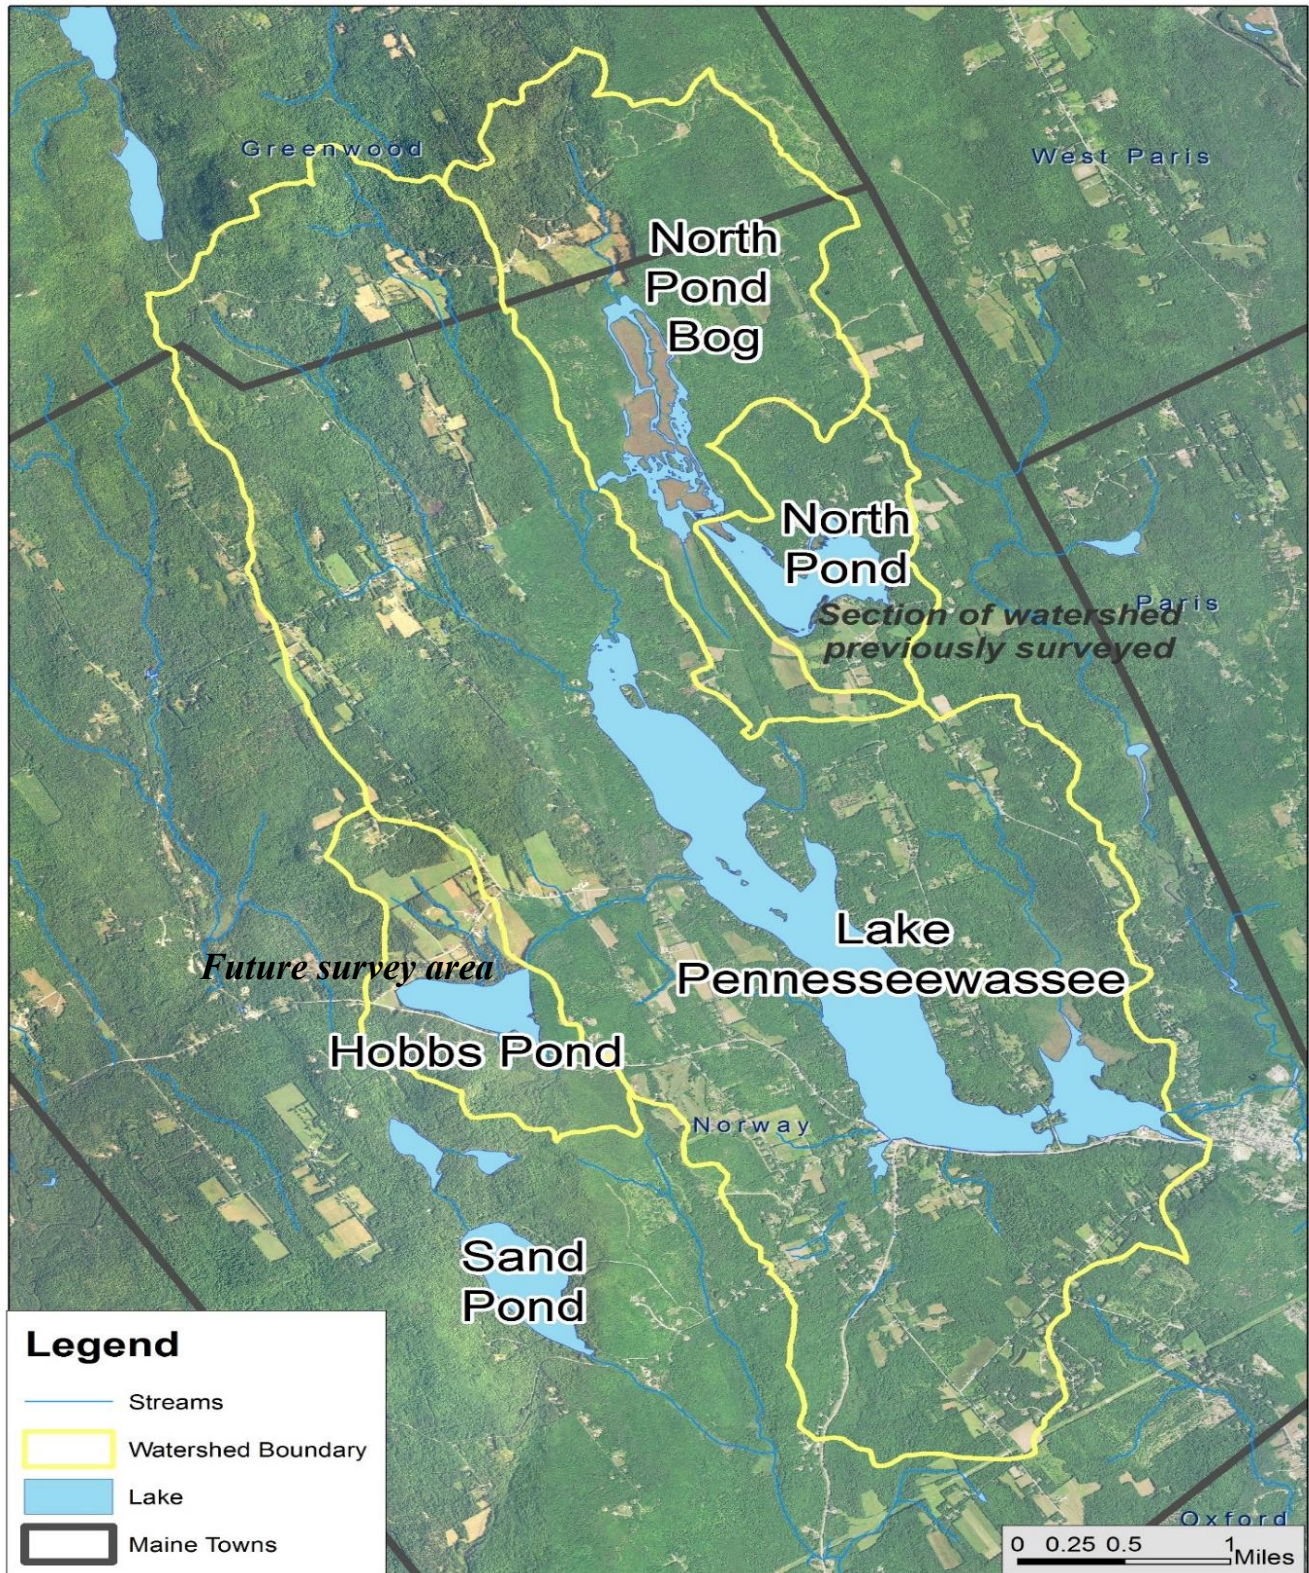
Figure 5. Map of Lake Pennesseewassee Watershed

The Lake Pennesseewassee watershed includes feeds from North Pond, North Pond Bog and Hobbs Pond, as well as a network of feeder streams, ditches and land that flows into the lake (Figure 1). There are both public and private roads within the watershed, and many of them are in close proximity to the lake. Many of the private roads have associations that raise funds to conduct varying levels of road maintenance. Watershed development includes agricultural areas and 277 shoreline year-round and seasonal homes on Lake Pennesseewassee. The watershed also contains numerous trails for walking, hiking, skiing, snowshoeing, ATVs and snowmobiles. The Western Foothill Land Trust owns several parcels of land within the watershed that are used for public access and the Town of Norway operates a town park and boat launch on the southern end of the lake. Two commercial marinas with private boat launches are located on the lake. State owned Rt 117/118 runs alongside Lake Pennesseewassee for over 1 ½ miles and the impact of this section on water quality is of particular concern. The watershed remains mostly forested although it is experiencing occasional new development.

Additional phosphorus flowing into Lake Pennesseewassee from North Pond and Hobbs Pond contributes to the phosphorus loading in Lake Pennesseewassee, which has the potential to lead to more algae growth.

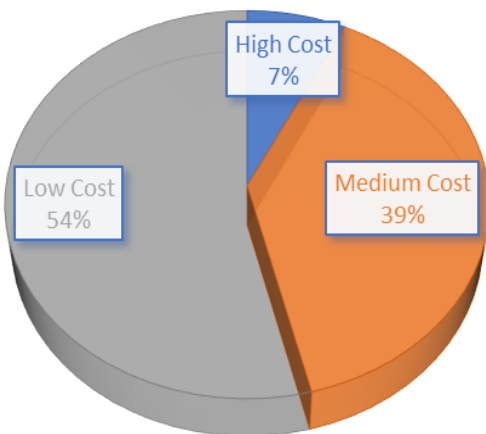
Figure 4. Estimated Cost of Remediation of Sites

Once field data describing the physical characteristics of each site was collected, a solution was recommended by the team technical lead and trained volunteers. An estimate of the projected cost and the technical skill level required to complete remediation was then made. Based on DEP recommendations, sites expected to cost more than \$2500 to remediate were classified as high cost sites. Those expected to cost between \$500 and \$2500 were classified medium and those expected to cost less than \$500 were low cost sites. A high technical level site might require an engineering design, a medium site would require a site visit by a technical person and a low complexity solution could be implemented by a property owner with reference materials. Figures 4 and 5 show the estimated ranges of cost and complexity of the 180 sites.

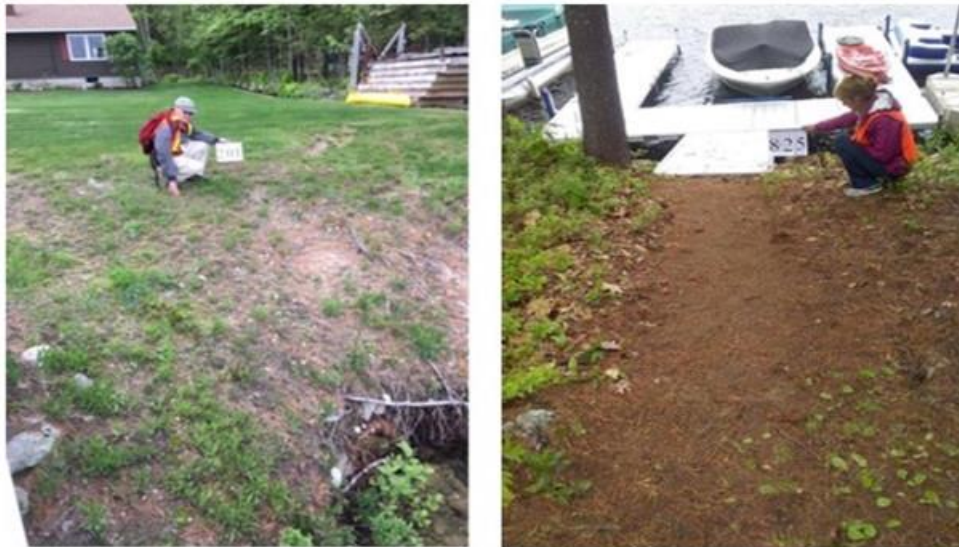
The most frequent problem on residential properties in the watershed was sheet erosion, often with bare soil, flowing directly into the lake. Rill erosion (i.e., with observable small channels carved into the soil) was another common problem along with inadequate shoreline vegetation, and unstable shoreline access. Depicted below are some examples of the most common problems found on residential sites and general recommendations to prevent erosion.

Figure 7. Heavy foot traffic, lack of vegetation and raking of pine needles make residential shoreline areas very susceptible to erosion

- Install runoff diverters/rubber razors.
- Define and stabilize footpath.
- Build infiltration steps.
- Avoid raking pine needles. Add mulch / erosion control mix to paths and trails.
- Reseed any bare soil and thinning grass, especially along shoreline.
- Establish buffer and add to buffer along shoreline.
- Build infiltration trench at roof dripline.

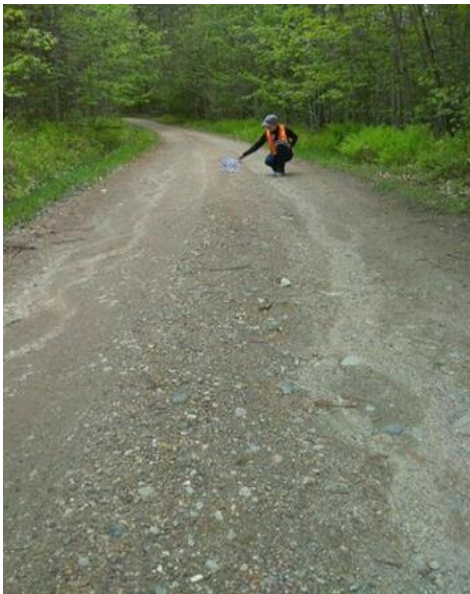
The most common observations related to roads were: sand and bare soil that would be washed into waterways (47 times); shoulder erosion (48 times); culverts that were clogged, crushed, or broken or had unstable inlets or outlets (43 times); surface erosion (18 times); and ditch erosion (24 times). There were also a few instances of roadside plow/ grader berm, especially on town roads. Examples of the most common problems and general recommendations are shown and described below.

Figure 8. Erosion on the surface of this private road washed into a ditch then into a stream that feeds Lake Pennesseewassee

- Replace failing or undersized culverts. Armor both ends of culvert with stone.
- Remove plow and grader berms that prevent runoff from getting off roads.
- Install runoff diverters (open top culvert, rubber razor or water bar).
- Stabilize road shoulders with gravel or stone.
- Stabilize road surface with hard-packing gravel and grade/crown to shed water.
- Reshape ditches and armor with stone.
- Employ Maine DEP certified contractors for road work.
- Utilize Maine DEP’s guidance documents for forming a road association and conducting road maintenance.

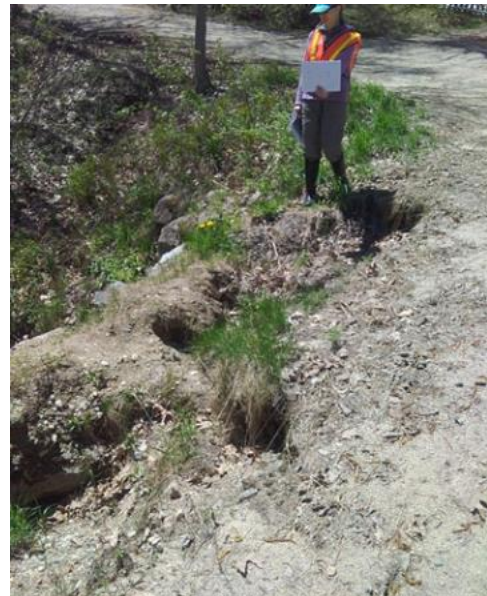
Figure 9. Severe erosion at a culvert

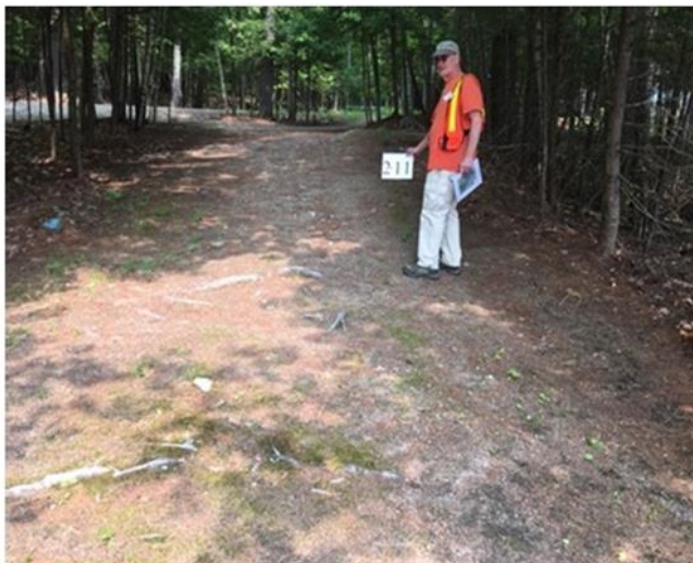
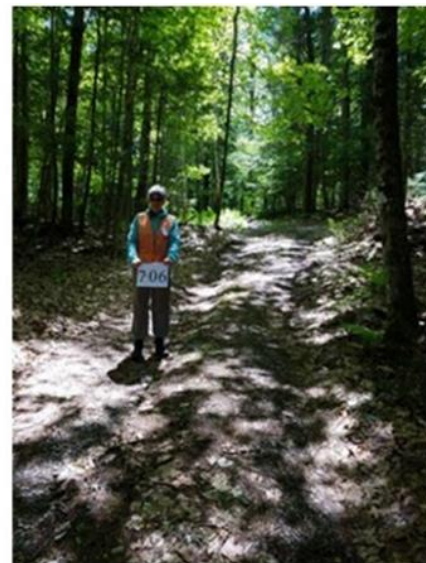
Figure 10. Runoff concentrates on these driveways then the eroded material washes into the lake

- Add new surface material, such as gravel.
- Reshape and crown driveway surface.
- Install runoff diverters (open top culvert, rubber razor or water bar).
- Define parking area and vegetate temporary driveways.
- Build a rain garden and establish vegetated buffer.
- Install gutters and drywell for roof runoff.
- Armor inlet/ outlet of culvert and install a plunge pool.
- Reshape ditches and armor with stone.

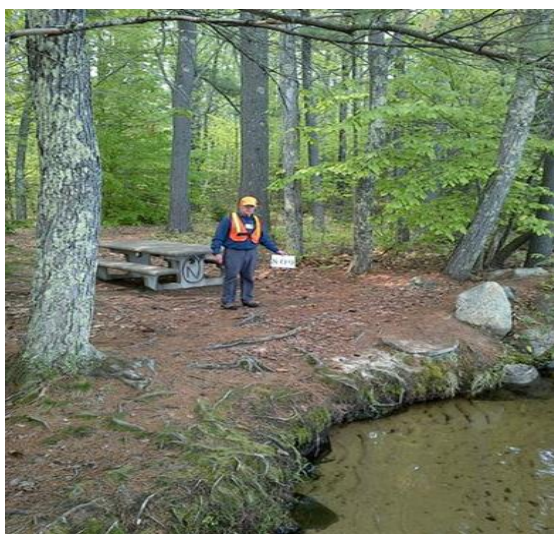
Figure 11. Lack of a vegetation buffer has resulted in shoreline erosion in this picnic area

- Don't utilize unprotected areas close to waterbodies, near ditches that can carry pollution into a waterbody.
- Armor heavily used areas to prevent erosion.
- Use silt fence or berm to contain erosion on construction sites.
- Apply Erosion Control Mulch.
- Establish shoreline buffers.

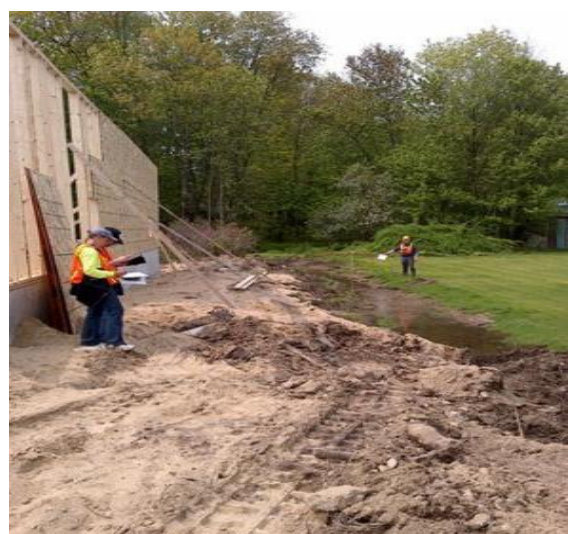
Figure 12. A construction project with inadequate protection of a ditch that leads to the lake
