LAKE PENNESSEEWASSEE WATERSHED SURVEY REPORT

JANUARY 2020

Lakes Association of Norway

Lake Penneesseewassee Watershed Survey

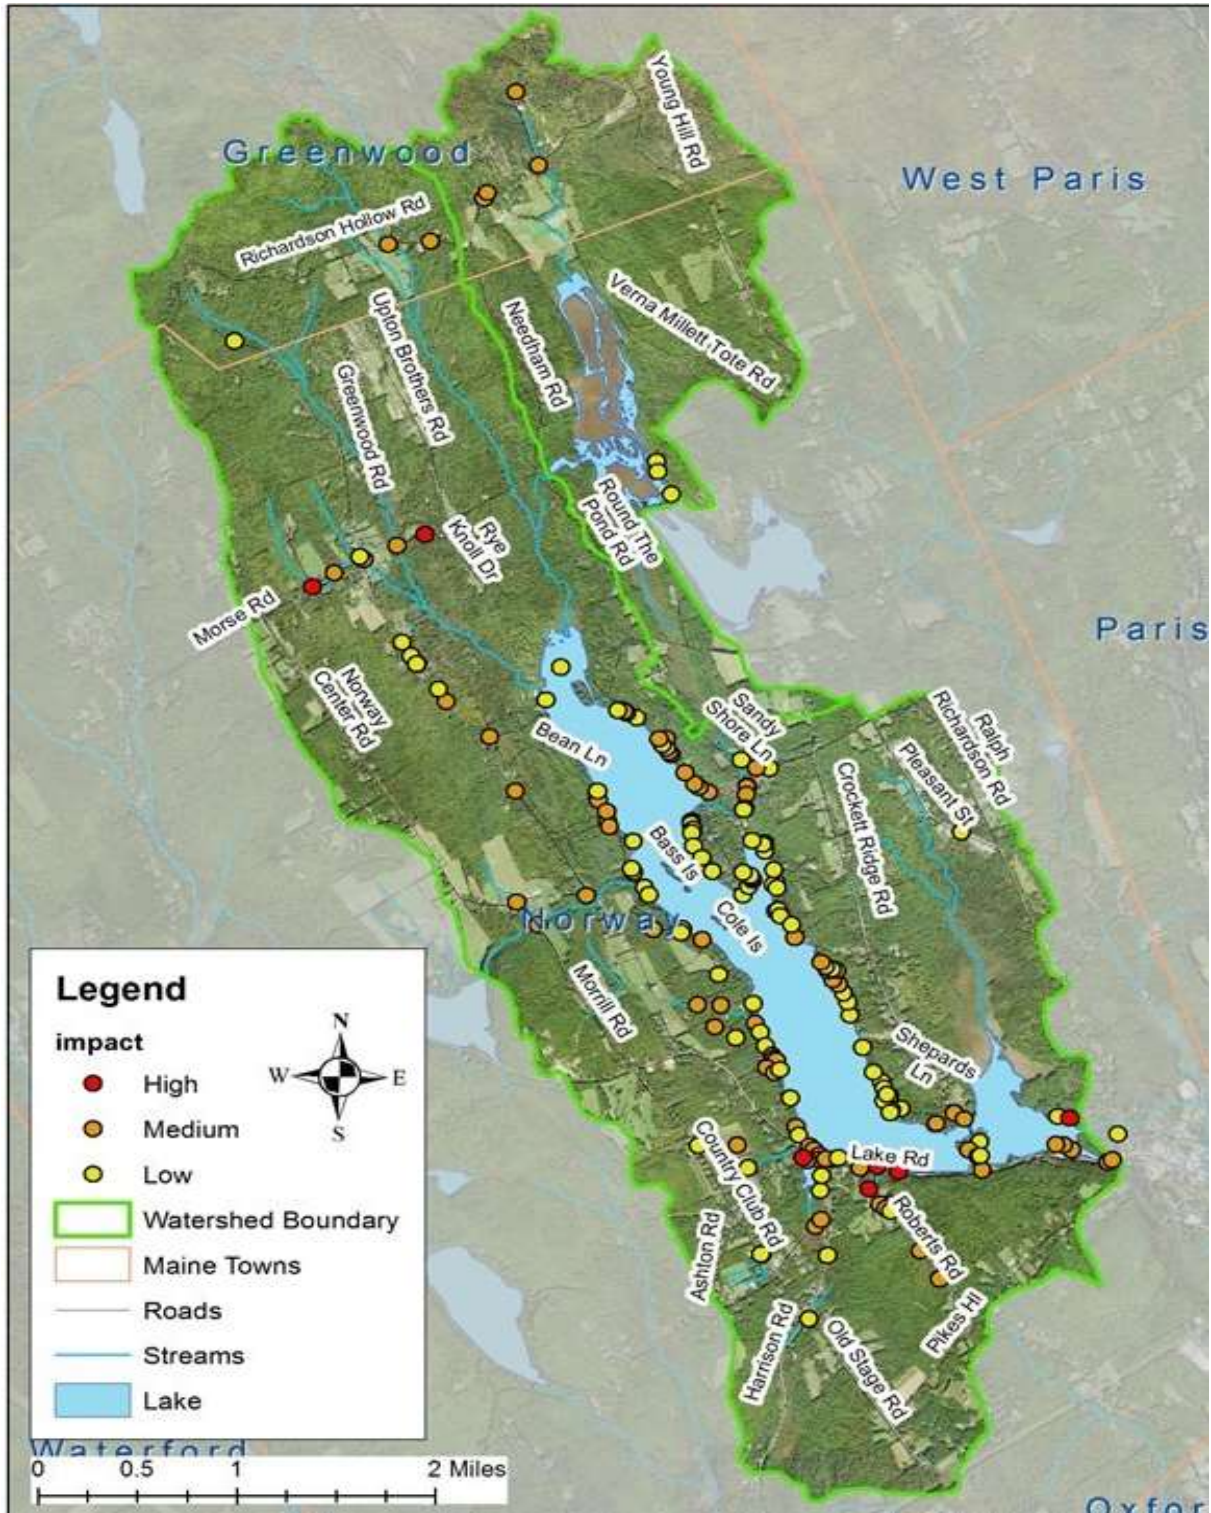
Figure 6. Map of Watershed Survey Erosion Sites¹

The following figures and tables summarize the survey results across 180 identified erosion sites. Residential properties had the highest number of documented sites followed by town, private and state roads, and then driveways. Other land uses made up less than 8% of the total sites and included beach or boat access, public and commercial areas, construction sites and trails. All sites received an impact score based on the type of erosion present, the size of the area involved and the type and density of vegetation present which could mitigate an issue. Ninety of the 180 sites received a compiled score that resulted in them being identified as having a low impact on the lake. Eighty-one were identified with a medium impact and nine with a high impact. Figure 6 is an overview map

of the Watershed Survey Erosion Sites. Appendixes A-1 through A-6 provide maps with more detail.
